# Intel<sup>®</sup> Pentium<sup>®</sup> III Processor Specification Update

Release Date: December 2006

Document Number: 244453-055

The Pentium<sup>®</sup> III processor may contain design defects or errors known as errata which may cause the product to deviate from published specifications. Current characterized errata are documented in this Specification Update.

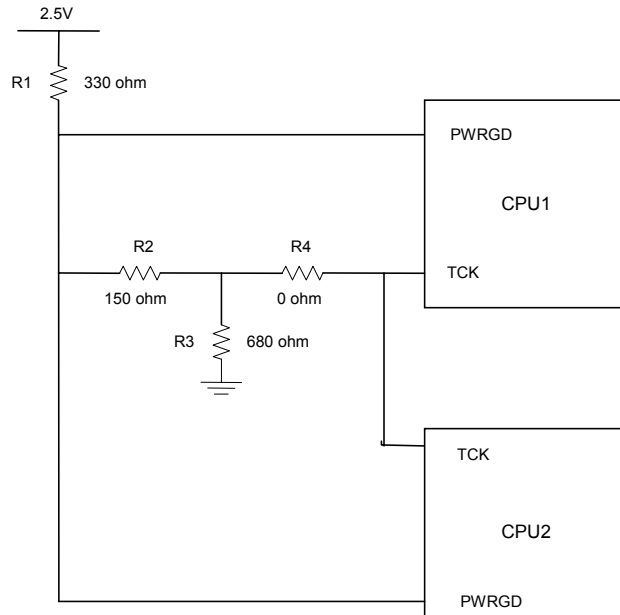
Pentium® III Processor with 512KB L2 Cache Platforms Workaround

In addition, the example workaround circuits shown do not support production baseboard test methodologies that require the use of the processor JTAG/TAP port. Alternative workaround solutions must be found if such test capability is required.

Assumes the inputs to the CPU\_PWRGD are open collector signals that are Wire-ANDed together

- The example workaround circuit assumes that the PWRGD inputs into the processors are open collector. Tying the PWRGD inputs together in a Wired-AND fashion allows each processor to receive PWRGD at the same time but at the latter of the 2 separate PWRGD assertions. If separation of the PWRGD inputs to each processor is required, extra circuitry will be required.
